Troubleshooting guide for MIS and MAC

Instructions for solving common issues

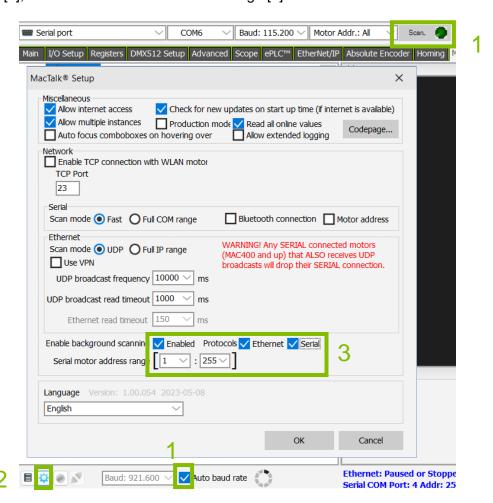
Ensure that no other programs on the PC is trying to use the chosen COM port. Open MacTalk and choose the search radar icon in the top right corner [1]. Select the auto baud rate checkbox. If this does not work, click the cog icon [2], and select the widest address range [3]. Then click OK.

If the motor still does not connect, select every baud rate one by one in the "Baud: " dropdown menu next to the scan button. If this does not work, follow the instructions in section 4: Force updating firmware.
