JVL
intelligent motors

Troubleshooting guide for MIS and MAC

Instructions for solving common issues

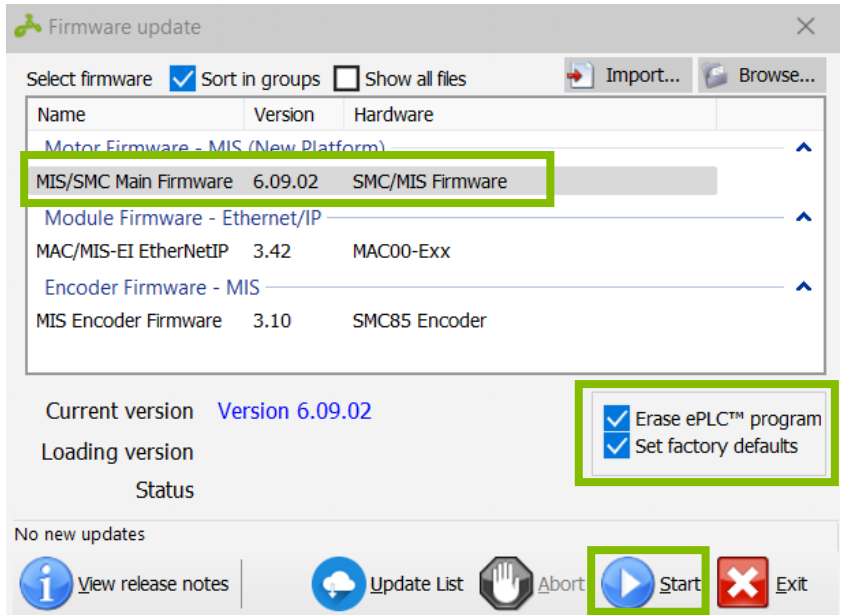
2	Select the correct firmware for your motor type. Note: Check the motor model. If it is incorrect, you can check the “Show all files” option and choose the correct firmware for your motor.

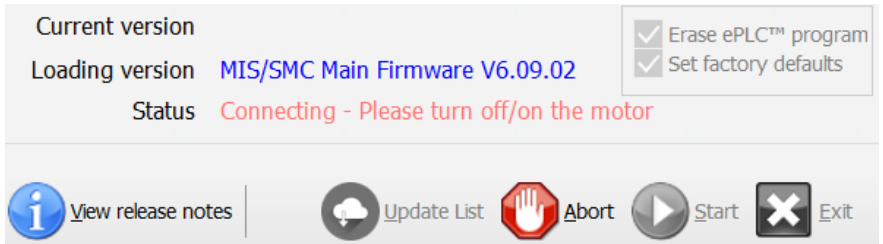
3	Once the pictured status message shows, turn on the 24 VDC supply.

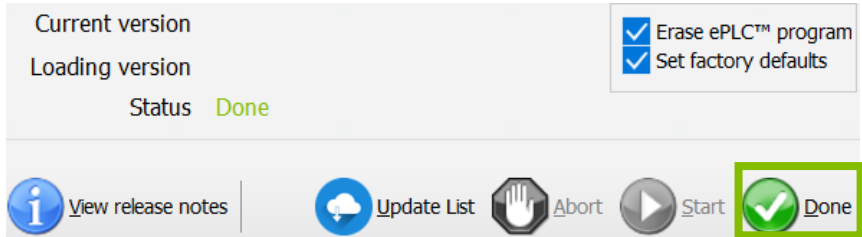
4	Once the update is complete, your motor will be back to default settings. Press “Done”

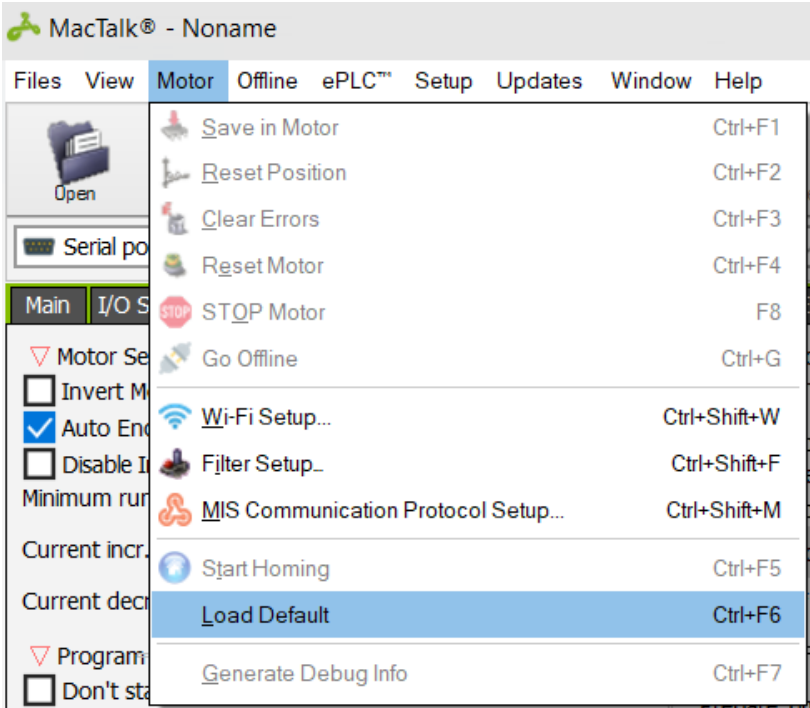
Step	Text	Image
1	Power on the motor and load default values in MacTalk (CTRL + F6).

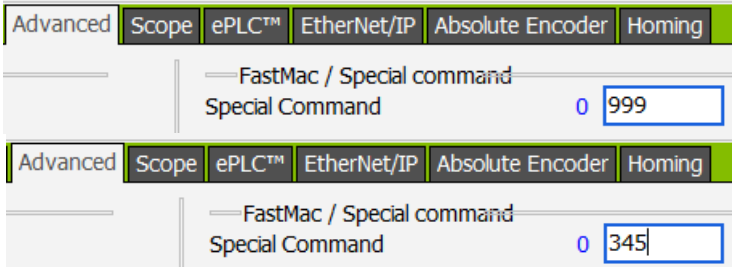
2	Issue command 999 and then 345. To verify that the command has worked, there should be no negative values in the P1/P2 registers.

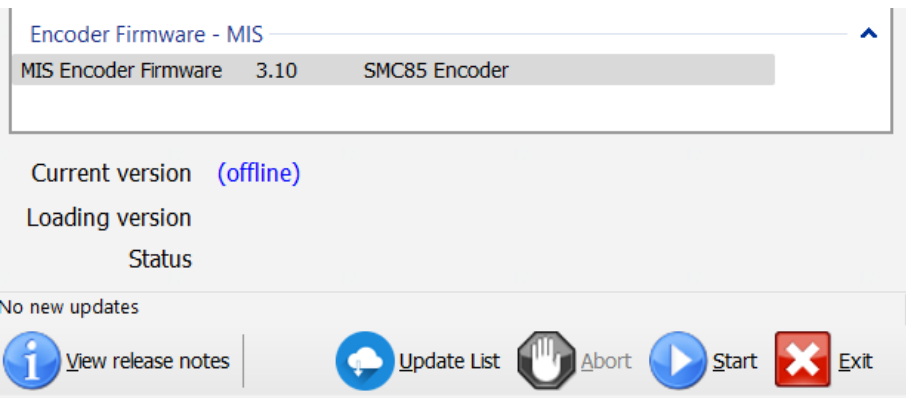
3	Update the encoder to the latest version.

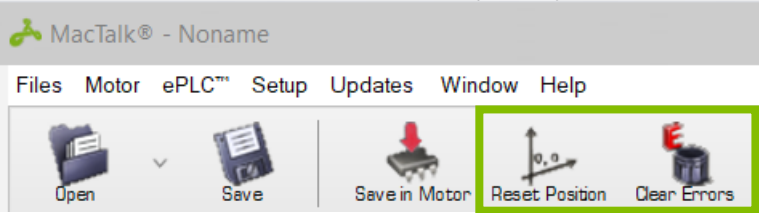
<p>4</p>	<p>After the update, the motor should display the following errors: Lost position, Encoder error.</p> <p>Click the “Reset position”, and “Clear errors”</p>

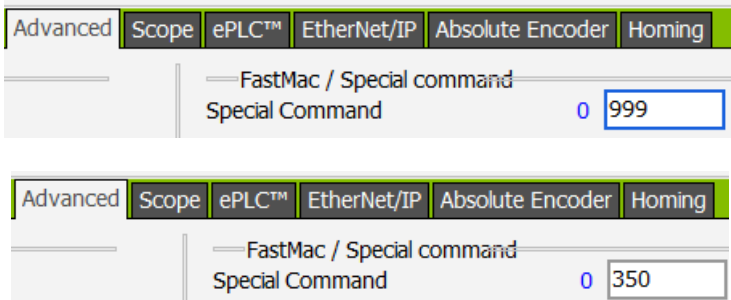
<p>5</p>	<p>With no load connected to the motor, issue command 999 and then 350.</p> <p>Wait for the motor to perform the calibration. This may take up to three minutes.</p> <p>When register P1 reads 64 or the motor stops moving, the process is finished.</p>	<p>Any load must be removed before performing this step!</p>

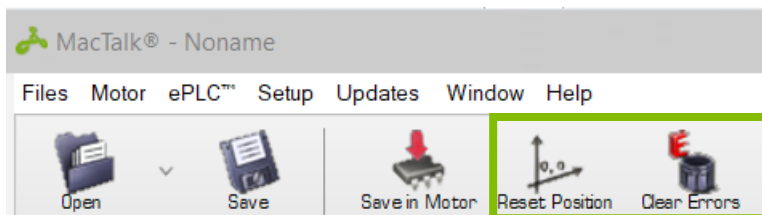
Click “Reset Position” and “Clear Errors”
